6 National Dam Inspection Program.

TUSCARORA LAKE DAM

(NDI I.D. PA-0049
DER I.D. 058-027)

~~OWNER: JAYNE'S ORCHARDS~~
Susquehanna River Basin, Tuscarora
Creek, Susquehanna County, Pennsylvania.
PHASE I INSPECTION REPORT

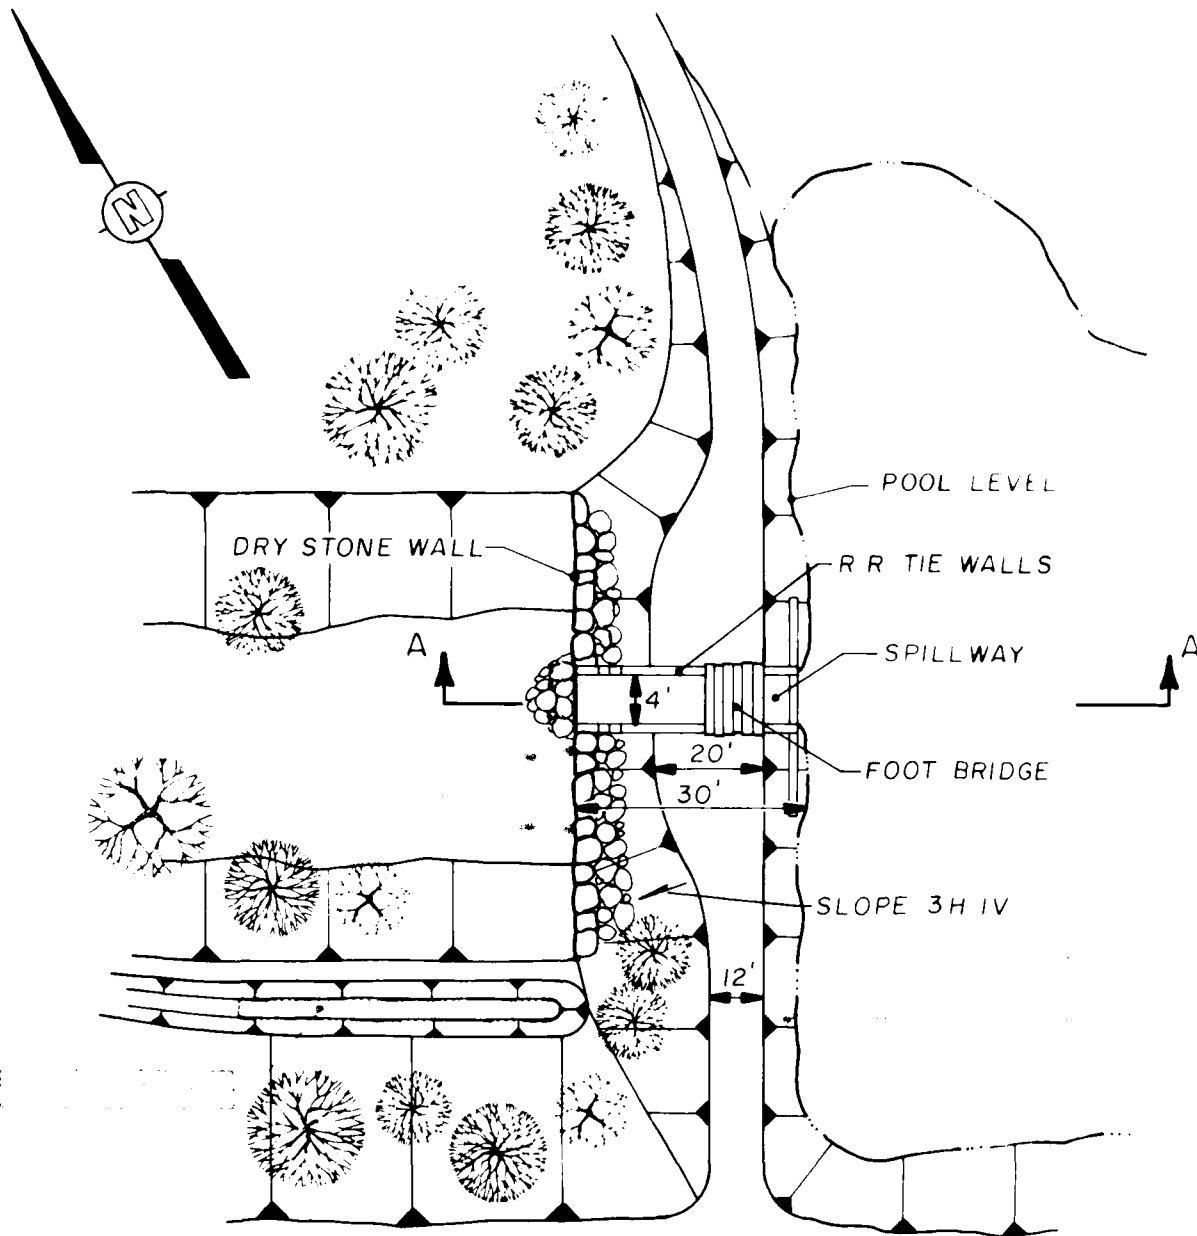
The specific observations are illustrated in Plate 2.

VISUAL EXAMINATION OF	OBSERVATIONS	REMARKS OR RECOMMENDATIONS
JUNCTION OF EMBANKMENT AND ABUTMENT, SPILLWAY AND DAM	No problems observed.	
ANY NOTICEABLE SEEPAGE	Seepage under the dam was observed along the downstream toe. See Plate 2 for seepage location.	
STAFF GAGE AND RECORDER	None	
DRAINS	None

POOL LEVEL AT DATE OF INSPECTION
-4" BELOW SPILLWAY CREST

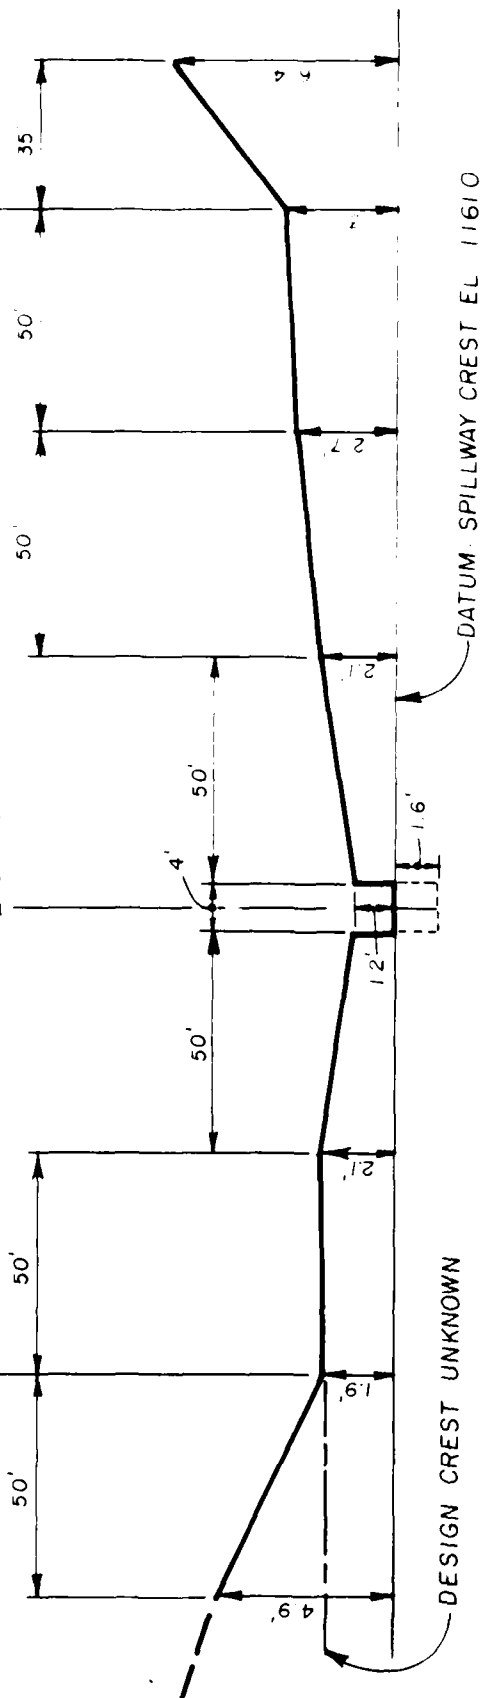
DAM CREST PROFILE (LOOKING DOWNSTREAM)

The crest of the dam was surveyed relative to the spillway crest elevation, and the crest profile is illustrated in Plate 3. A 30- to 50-foot section of the embankment on each side of the spillway was found to be lower than the remaining portions of the dam.
